# Aesthetic Restoration of Severely Crowded Anteriors

## Phased Restorative Approach

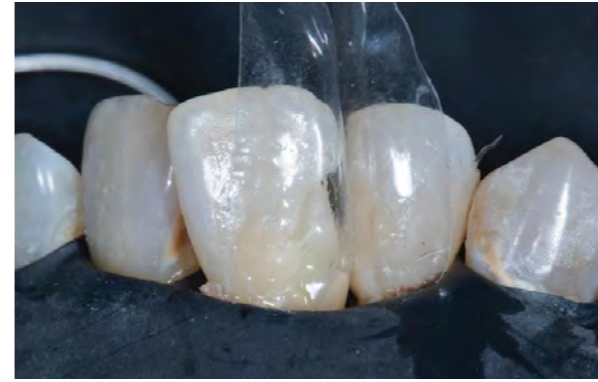
9. Bioclear Matrices placed and Beautiful Injectable X shade A2 injected.

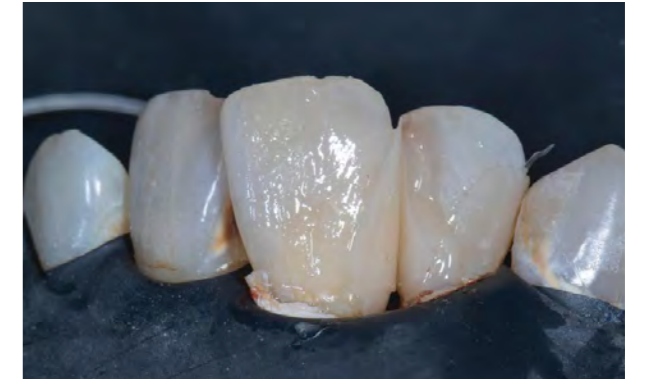
10. Build-up completed with the convenience of Inject & Shape.

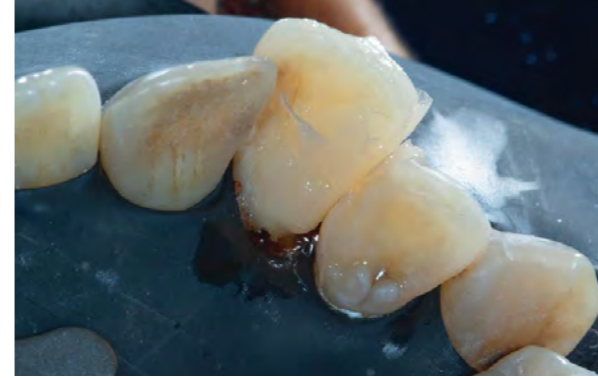
11. The excess material removed with a fine diamond bur.

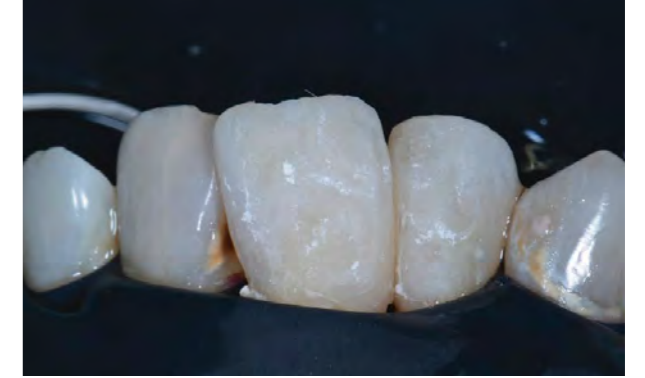
12. After removal of the excess material.

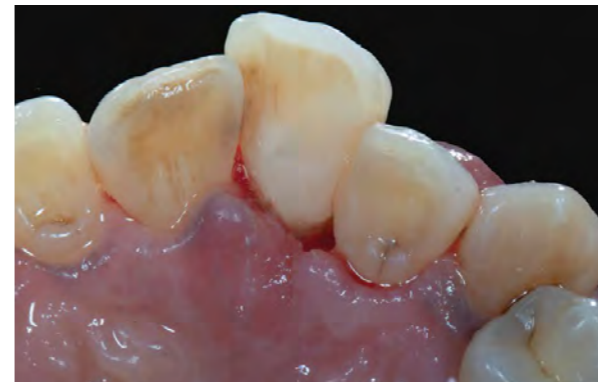
13. After finishing the restoration on tooth #11

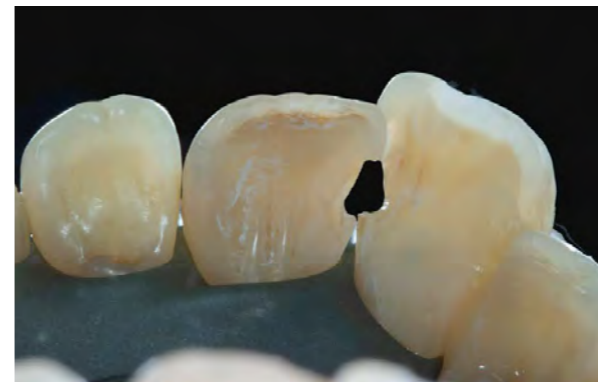
14. Cavity preparation on mesial surface of tooth #11 & 21.

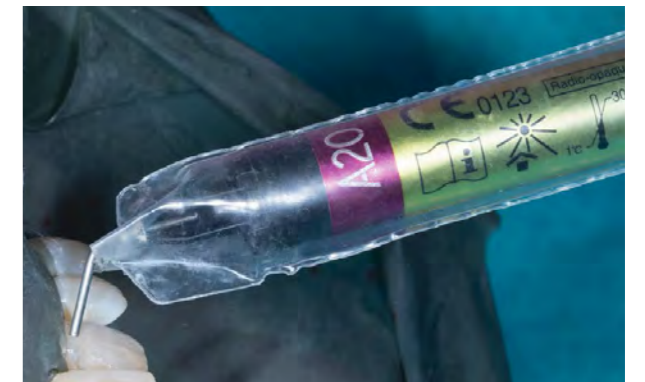
15. Restoration of the mesio-cervical area with Beautiful Injectable X shade A2O.

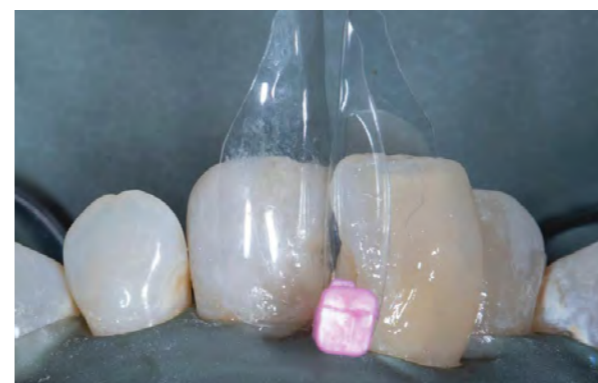
16. Bioclear matrices placed and restoration of tooth #11 & 21 were done simultaneously with Beautiful Injectable X shade A2.

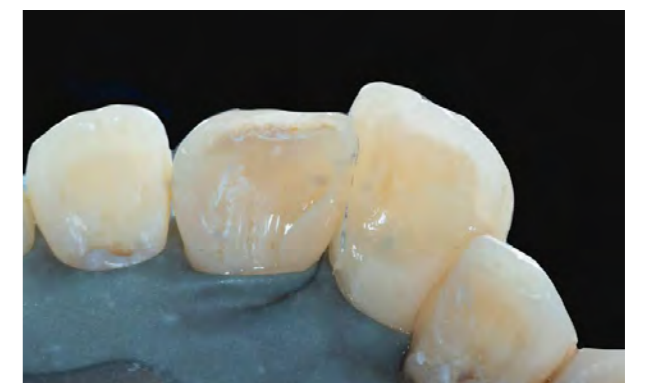
17. Well contoured restorations with minimal excess.

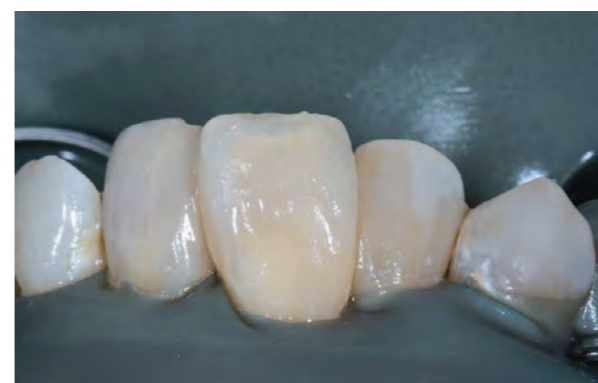
18. Finishing and polishing all the restored surfaces on tooth #11, 12 & 21 with Super-Snap Xtreme disk system and OneGloss.

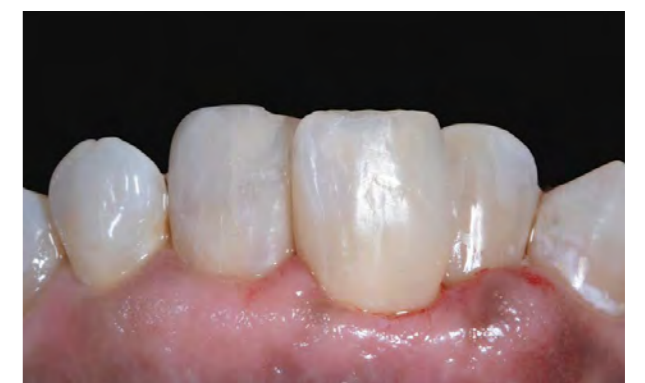
19. After removal of rubber dam and super polishing with Diamond Polishing paste and Super-Snap disk.

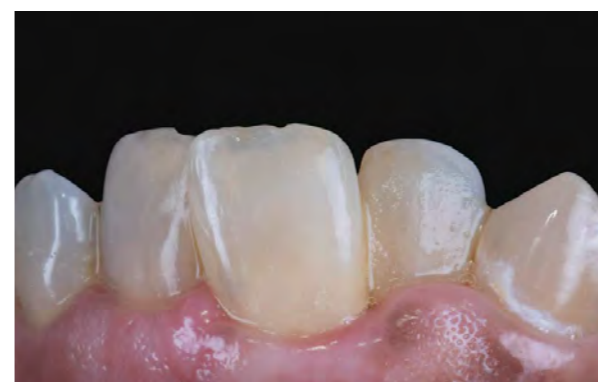
20. Recall visit after one week.

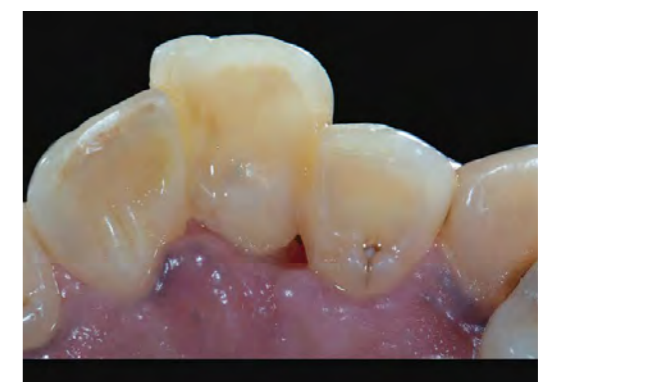
21. Visible healing of the distal papilla after one month post-op.

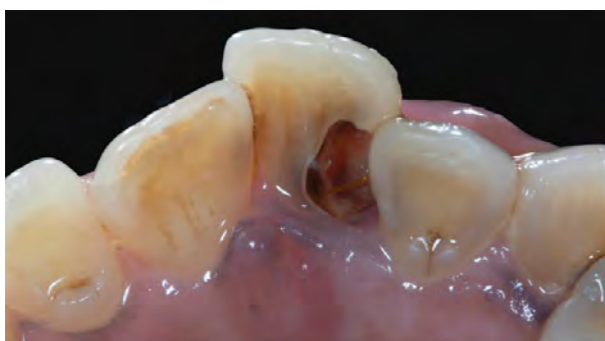
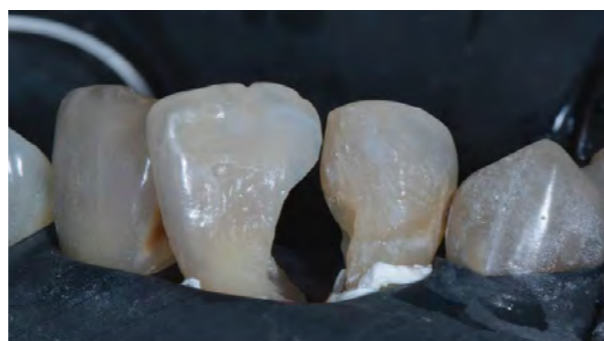
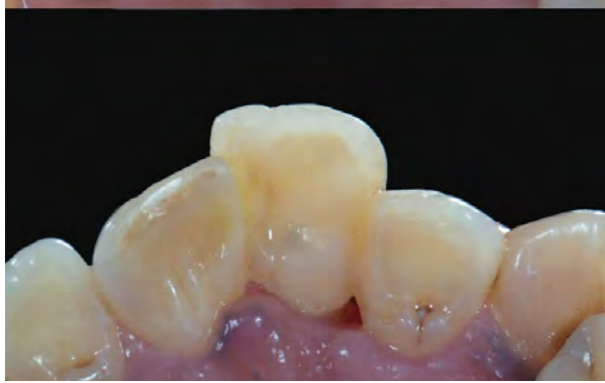
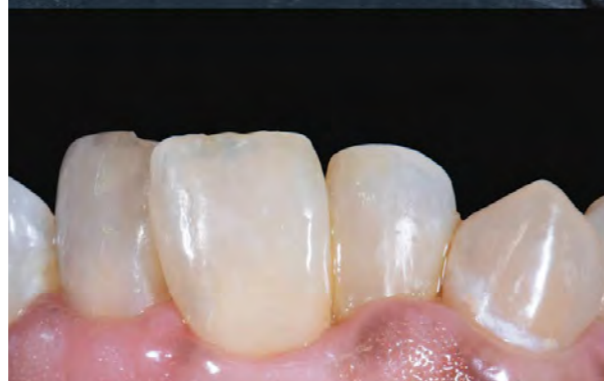
55 years old female patient visited the dental office with a chief complaint of pain in the upper front tooth. Clinical examination and IOPA radiograph revealed badly decayed tooth 11 with multiple class 3 cavities on tooth #12, 21. This complex case was managed based on a phased treatment approach in 3 stages.

1 & 2. Palatal and Labial view of before and after restoration

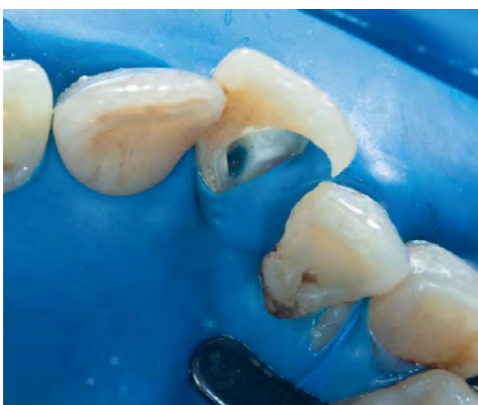
3. After removal of caries in tooth #11, 12 and you need patience to invert the rubber dam in such a deep cavity margin.

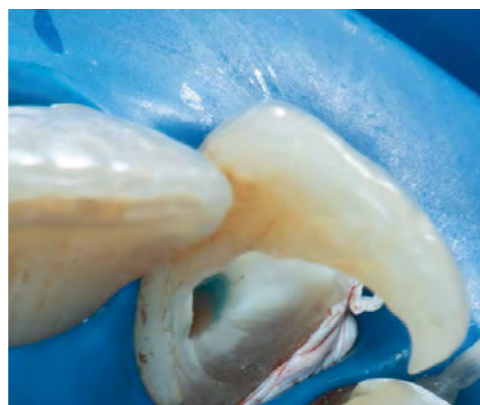
4. After careful insertion perfect seal achieved with teflon tape which rolled like a retraction cord before root canal treatment.

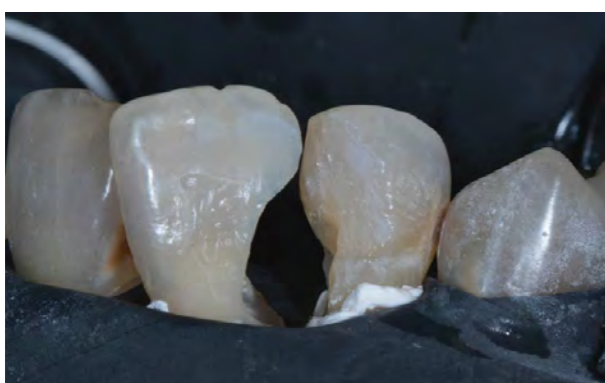
5. Cavity walls were prepared for the adhesive procedure before placement of Post & core on tooth #11 after RCT. Post selected due to severe destruction of palatal surface.

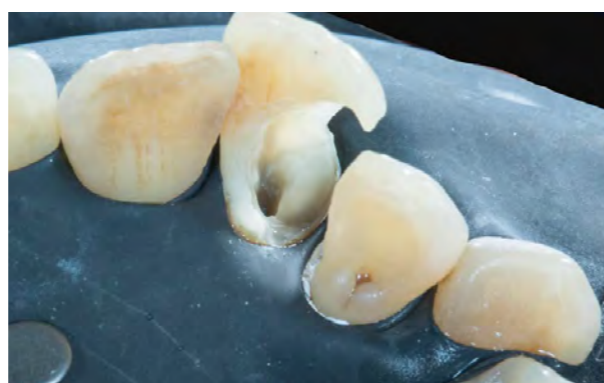
6. Palatal view after air abrasion and acid etching on Tooth #11

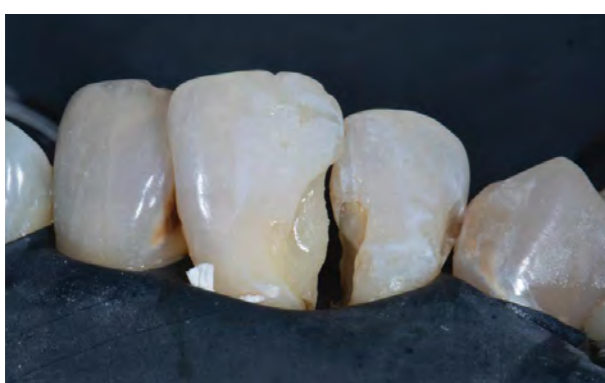
7. After bonding the post, full anatomical build-up on tooth #11 with Beautiful II LS shade A2O.

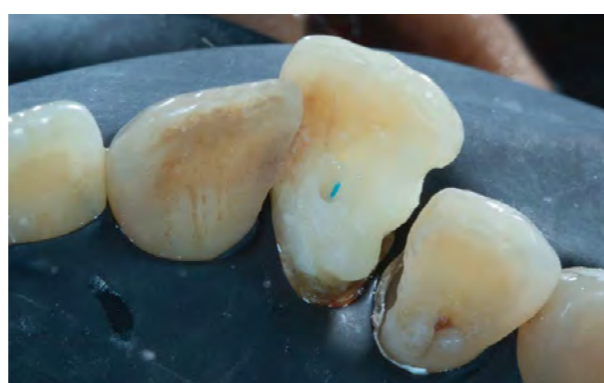
8. Palatal view of the free hand build-up of tooth #11 after bonding the post.
