Anterior Fracture

A 27 year old businessman presented with a chipped upper anterior tooth. After examination and shade selection the chipped central incisor (#21) was restored using the direct silicone template technique. The main clinical challenge of this case was to obtain adequate retention with beveled margins.

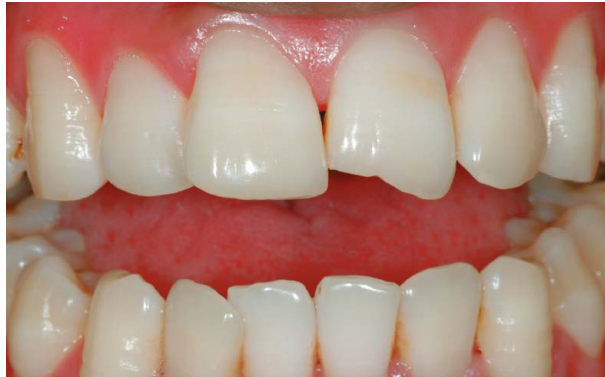
1. Incisal fracture on tooth #21.

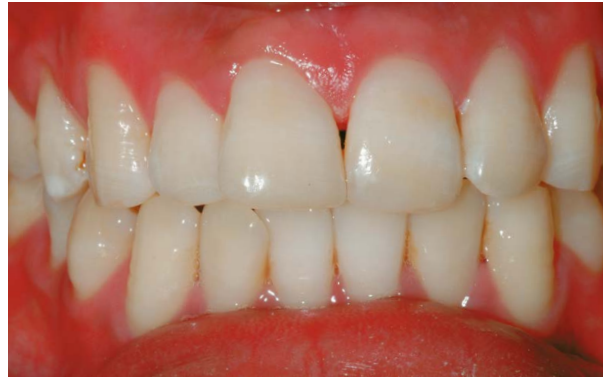
2. After placing a direct cosmetic restoration.

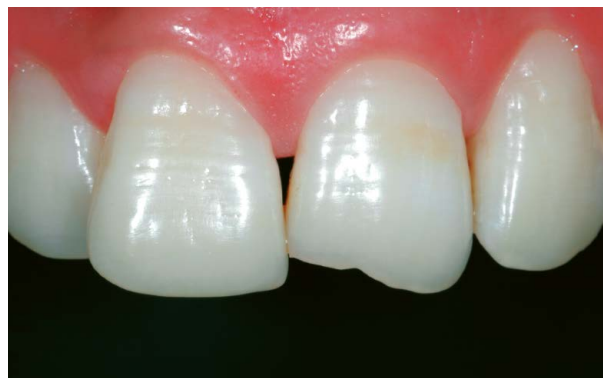
4. A clear view of the fracture.

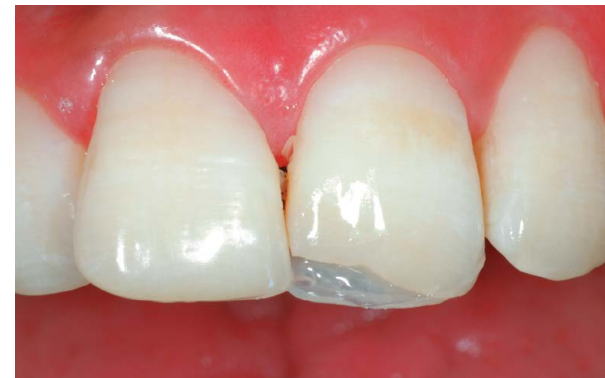
15. Lingual matrix after light-curing.

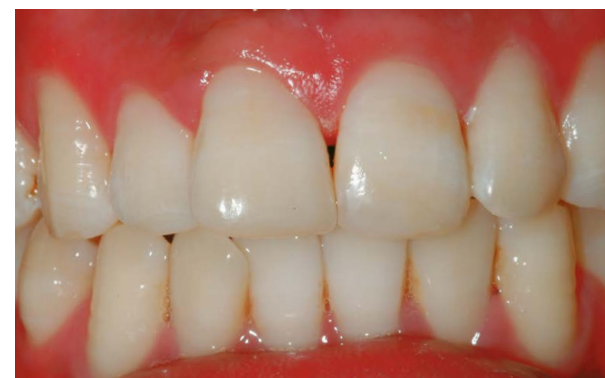
21. Restored tooth #21 after super polishing.
